ERDC/GSL TR-03-24

## **E-Krete™ Polymer Composite Micro-Overlay for Airfields: Laboratory Results and Field Demonstrations**

November 2003

Final report

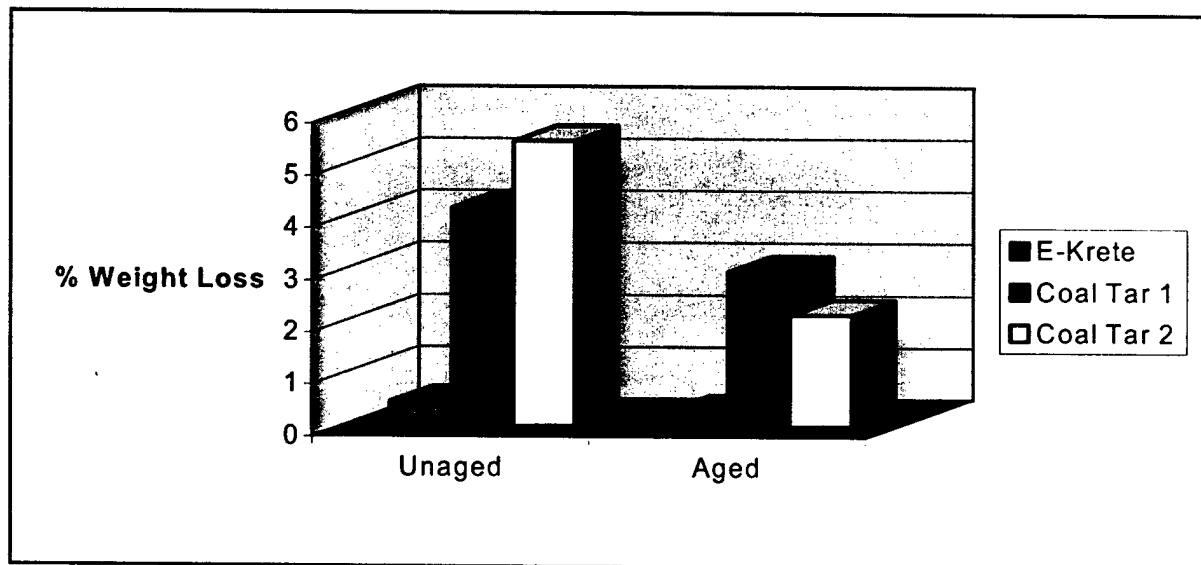
The results of the abrasion testing indicate that the unsealed E-Krete™ material is approximately 8 to 10 times more abrasion resistant than a standard coal tar emulsion. The sealed E-Krete™ is approximately two times more abrasion resistant than the CTE. The difference between the sealed and unsealed E-Krete™ indicates that the surface sealer is abraded more rapidly than the E-Krete™ base. Although the abrasion resistance of the CTE's is higher after aging because of the embrittlement, it is well documented that these materials exhibit severe "chicken-wire" or "map" cracking with age and must be resealed every 3 to 6 years (Shoenberger 1993 and Saraf, Majidzadeh, and Kumar 1992). There is no statistical loss in abrasion resistance after aging of the E-Krete™ material. The reduced variation in the test results for E-Krete™ indicates the consistency of the product.

Figure 1. Abrasion resistance of E-Krete™ compared to coal tar emulsion using a modified form of the wet track abrasion test

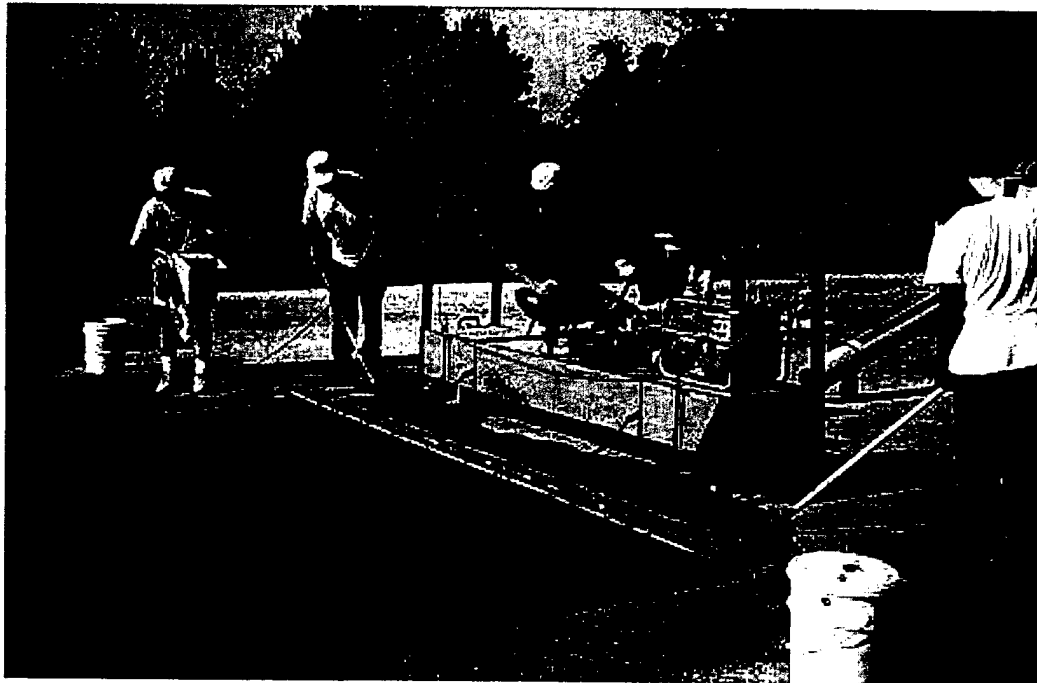
The E-Krete™ was placed in the morning of August 25, 1998, under clear skies in temperatures ranging from 27 to 35 °C (80-95 °F) and 50 to 60 percent relative humidity. Pavement temperatures were above 50 °C (122 °F) at the start of the demonstration. The materials were mixed on-site in a mortar mixer and placed in approximately 2 hr. The area covered was approximately 140 sq m (1,500 sq ft). The E-Krete™ material (pigmented black) reached a non-tacky condition within 15 to 25 min. No particular problems were encountered during the placement (Figure 2). The test area is in a remote location at ERDC and receives very little traffic.

Figure 2. Application of E-Krete at ERDC, August 1998
